## Maintenance Status

**This aircraft, N9225Y, was personally inspected on: February 23, 2004 by: Thomas E. Rogers, member of the National Aircraft Appraisers Association, at: Manchester Municipal Airport, located at Manchester, Hillsborough County, New Hampshire.**

***National Aircraft  
Appraisers Association  
Certificate of Appraisal***

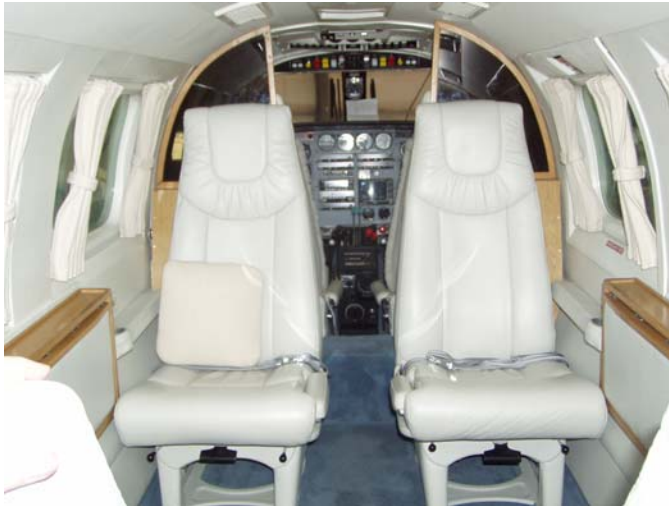
**Comments:** On 3/3/03, Belair-Air Interiors replaced the interior with leather and sheepskin upholstery, Hafner carpets, new curtains, headliner and seatbelts. The carpets and seats are clean and free of stains. There are small cracks at the fitting points on the overhead speaker trim and the window trim at the top of the left, second passenger window. Small scuff marks appear on the legs of the passenger seats. The rear baggage compartment is clean and free of damage. The toilet is located under the

aft side-facing seat.

The cockpit is clean, showing no damage on the seats, armrests or window trim. There are several small cracks in the overhead switch panel and several minor scratches on the instrument panel at the upper left and right corners, around several fittings and instruments.

The window and windshield glass are clear with only minor scuff marks near the pilots vent window and the right aft cabin window.

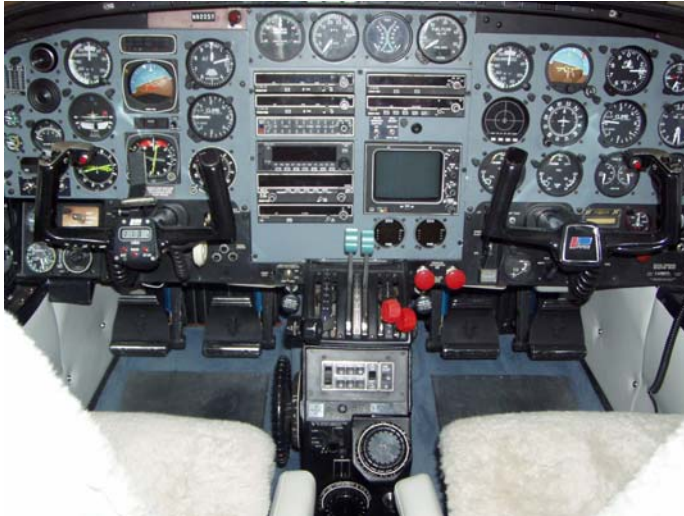
**Comments:** The panel is well laid out in the standard "T" pattern. Instruments markings and glass are clear. Switch and control labels are well marked, showing only minor wear around high use controls.
